Evaluation of Post Flooding Shoulder Reconditioning

Prepared by:
Junliang Tao, Zhe Luo and Ganesh Pandey

Prepared for:
The Ohio Department of Transportation,
Office of Statewide Planning & Research

Final Report

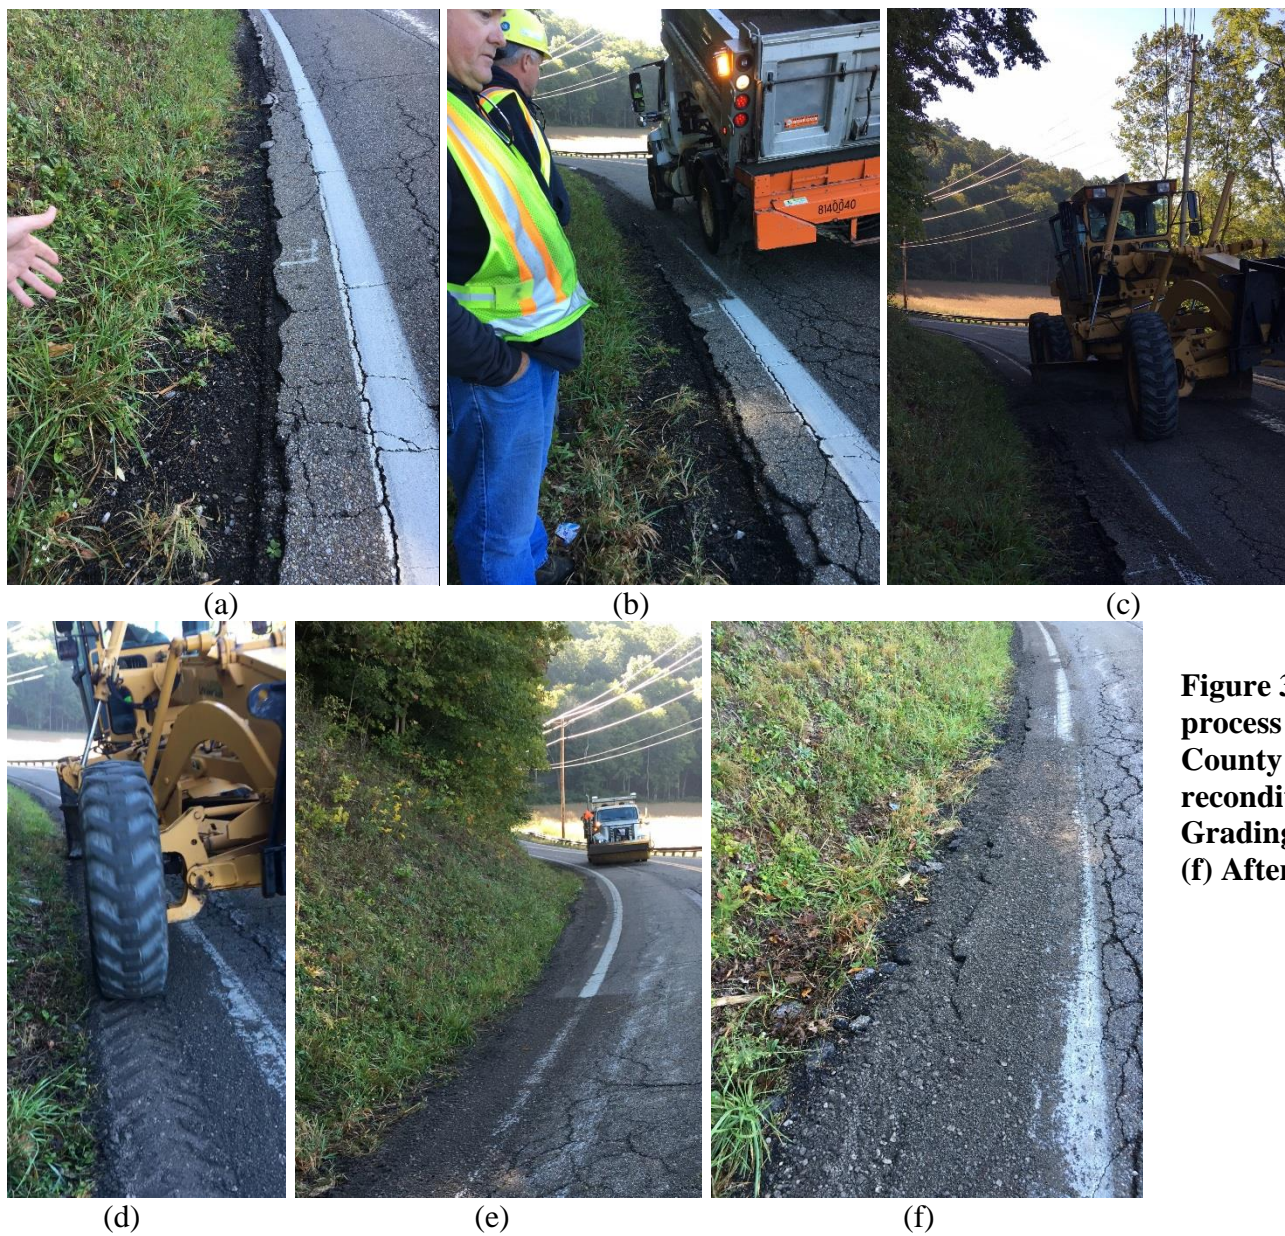
Figure 3. The shoulder recondition process adopted by ODOT Holmes County garage. (a) Before reconditioning; (b) Filling material; (c) Grading; (d) Compaction; (e) Cleaning; (f) After reconditioning

To better evaluate the current practice, especially the implementation of the Item 617, the research team observed the shoulder recondition process at the SR 60 site shown in Table 4. Photos and videos were taken to document the equipment and procedures. As shown in Figure 2a, the road is located along a hillslope and the shoulder is very narrow with a width smaller than 2 ft. Vegetation is established on the hillslope but not on the shoulder section. Between the shoulder and the hillslope, there is no ditch or alternative drainage system. Obvious traffic rutting on the shoulder section can be observed, and the drop-off at the shoulder section is apparent. The reconditioning work begins by filling the drop-off sections with Item 314 materials from a dump truck (Figure 2b); a grader is then used to level the aggregate surface with the pavement (Figure 2c); the

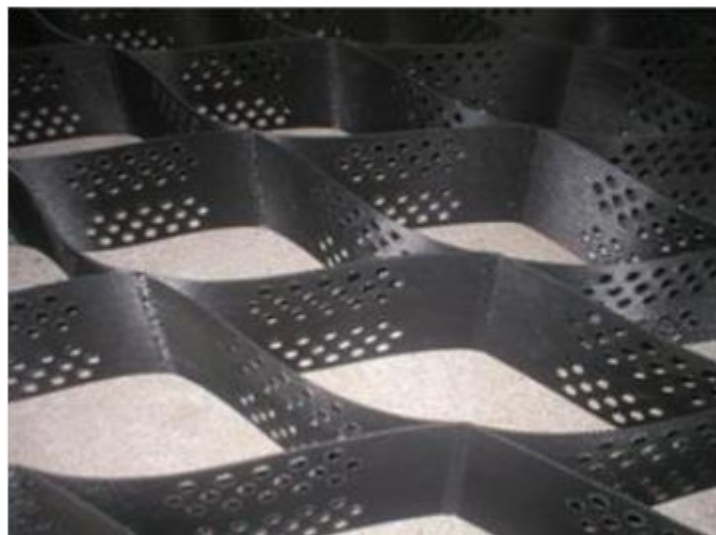
Figure: Close view of geocell pockets.
